OLYMPUS
35 DC
REPAIR MANUAL

OLYMPUS OPTICAL CO., LTD. TOKYO, JAPAN

35 DC

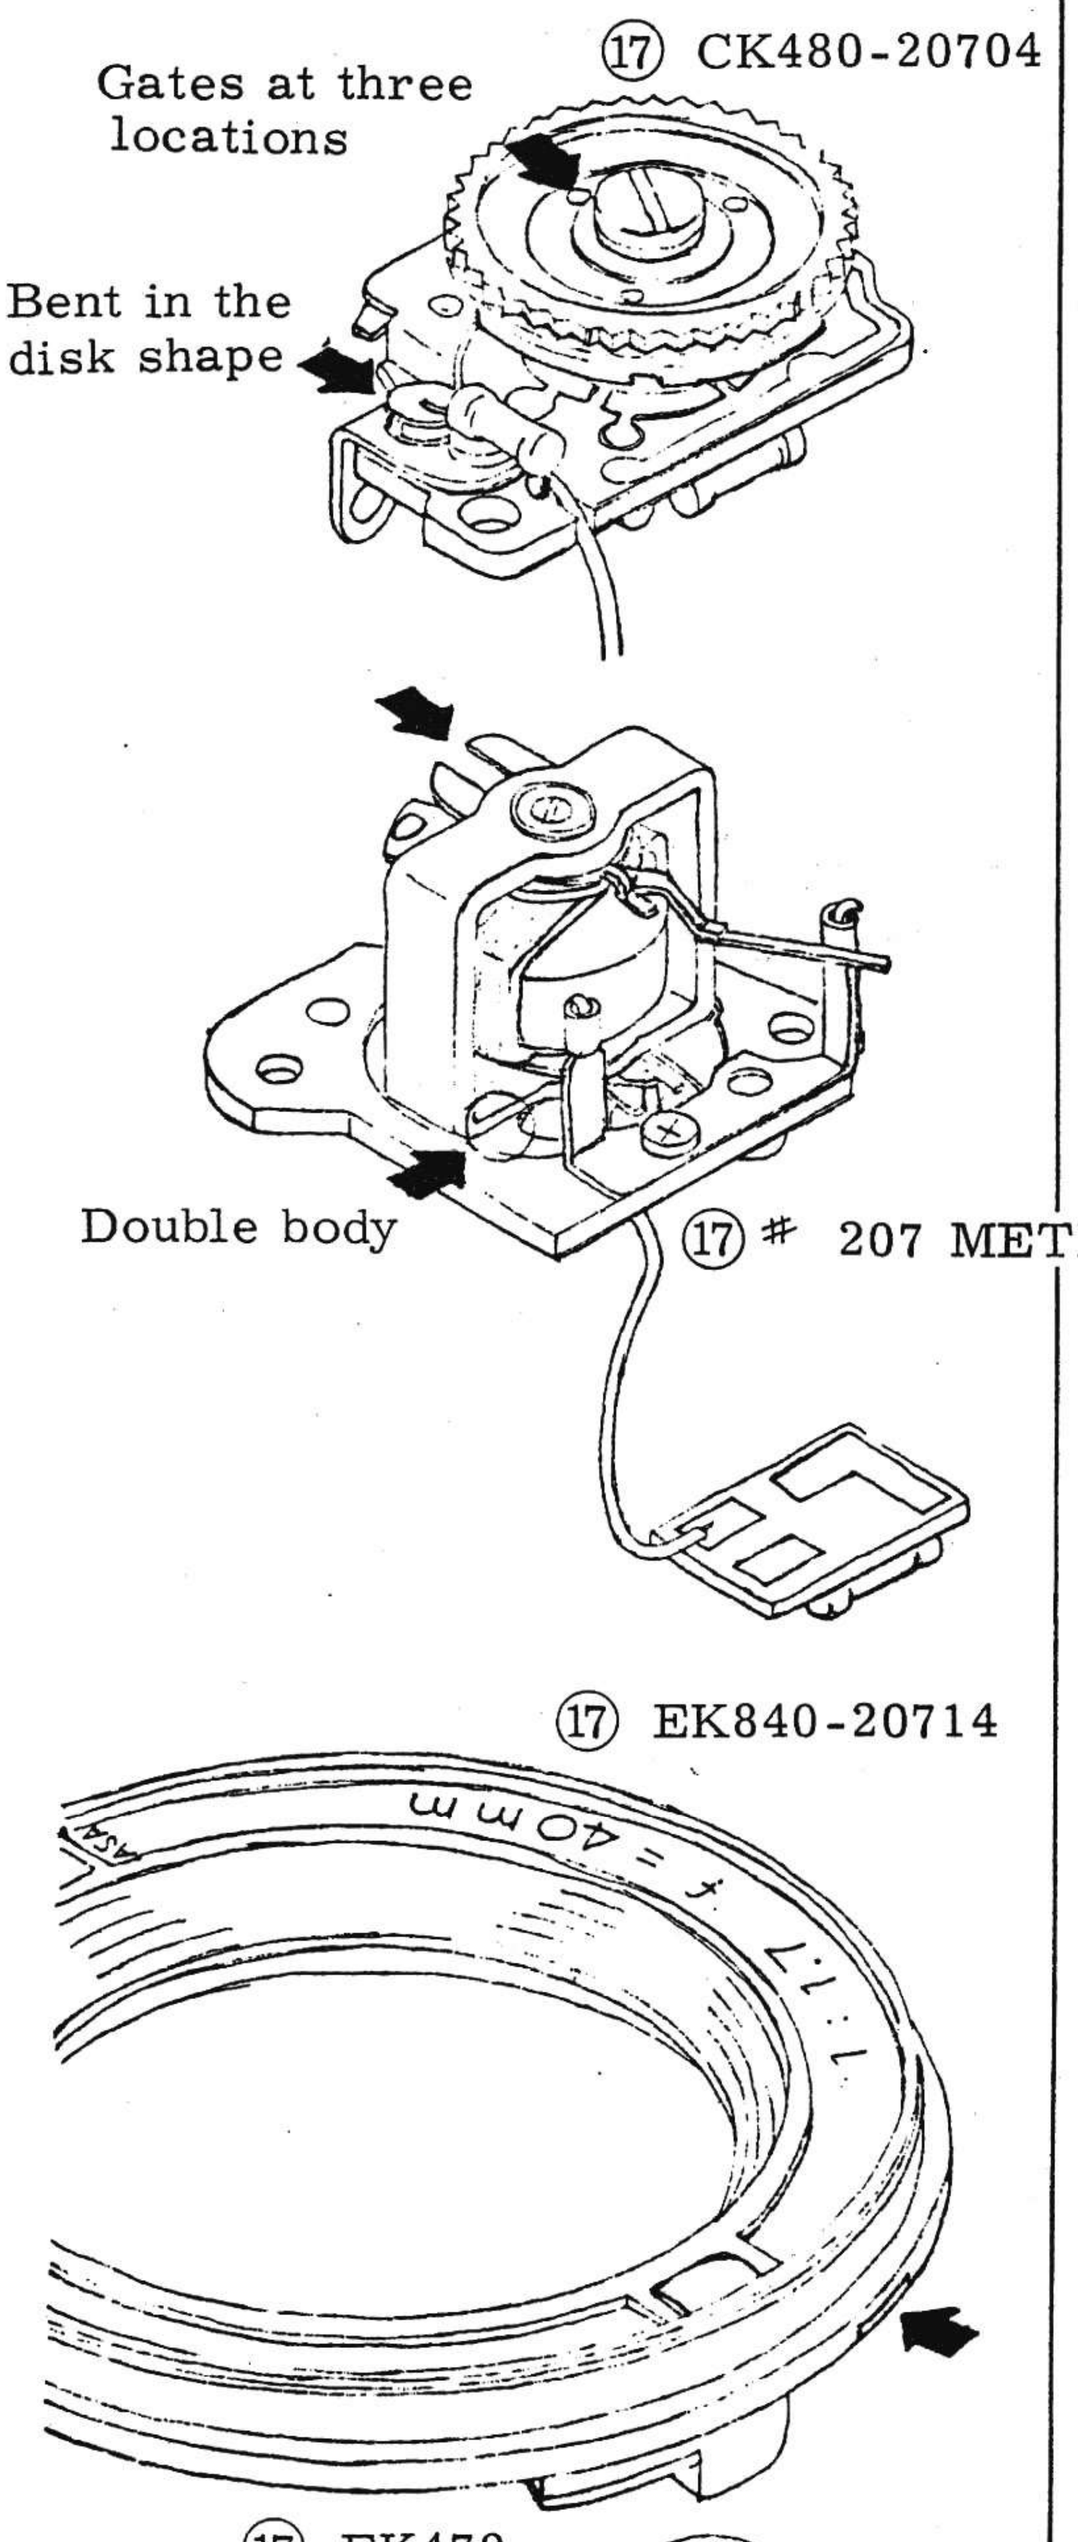
Fig. A

⑰ CK480-20704
Gates at three locations
Bent in the disk shape
Double body
⑰ # 207 METER
⑰ EK840-20714
⑰ EK470
-20722
-20723
-20724
-20725
⑰ EK210
-20717

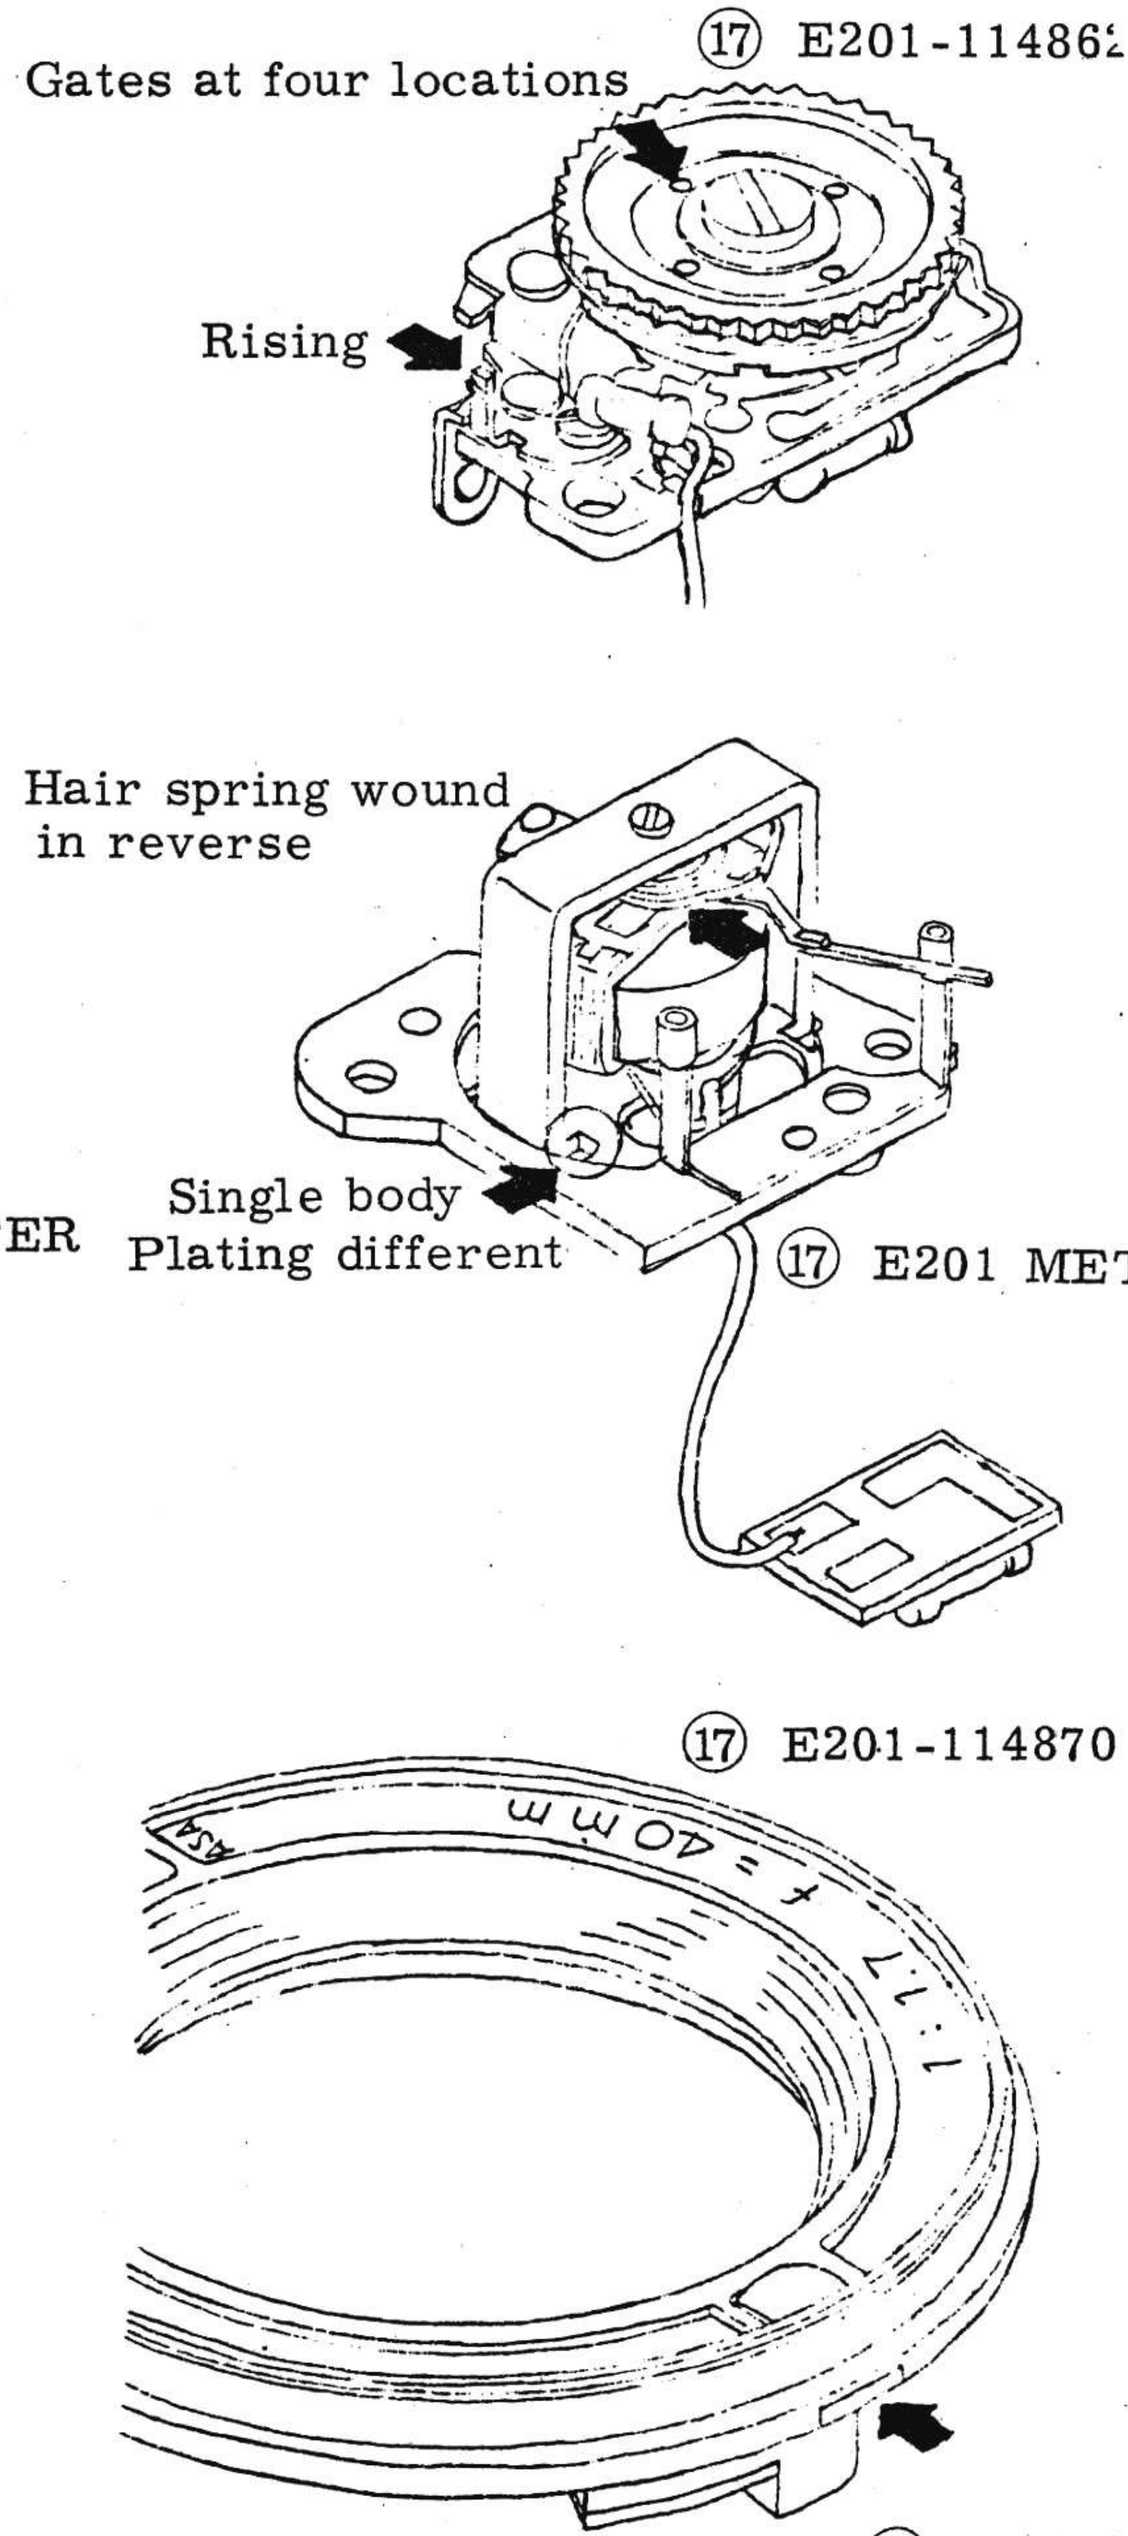
Fig. B

⑰ E201-11486
Gates at four locations
Rising
Hair spring wound in reverse
Single body
Plating different
⑰ E201 METER
⑰ E201-114870
Rotation stopper fitting part position changed
⑰ EK470
-20722
-20725
⑰ EK210
-20717

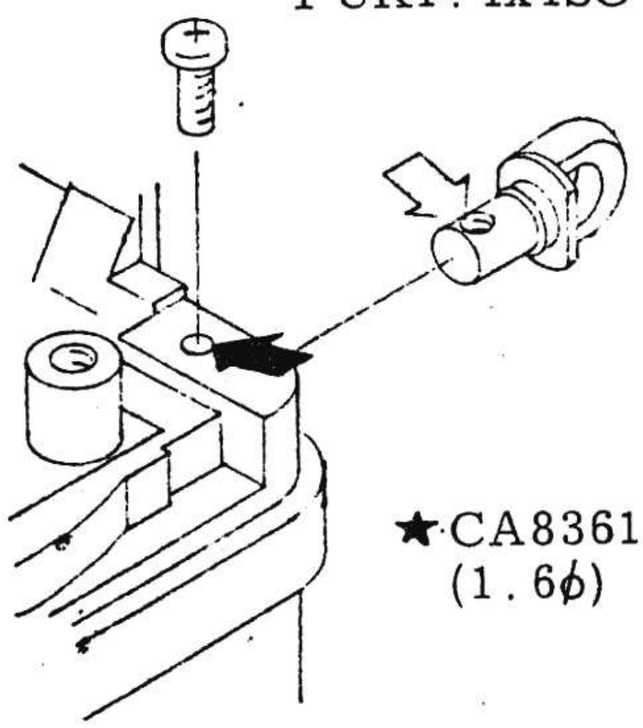
Fig. A

PUK1.4x4SO

* When the PUK1.4x4SO is broken enlarge the CA8361 1.6ϕ to 1.9ϕ and replace it by the part of (1) and do the repairing.
